# Thermal Imaging for Home Inspectors

## Moisture in Building Materials – EIFS Flashing

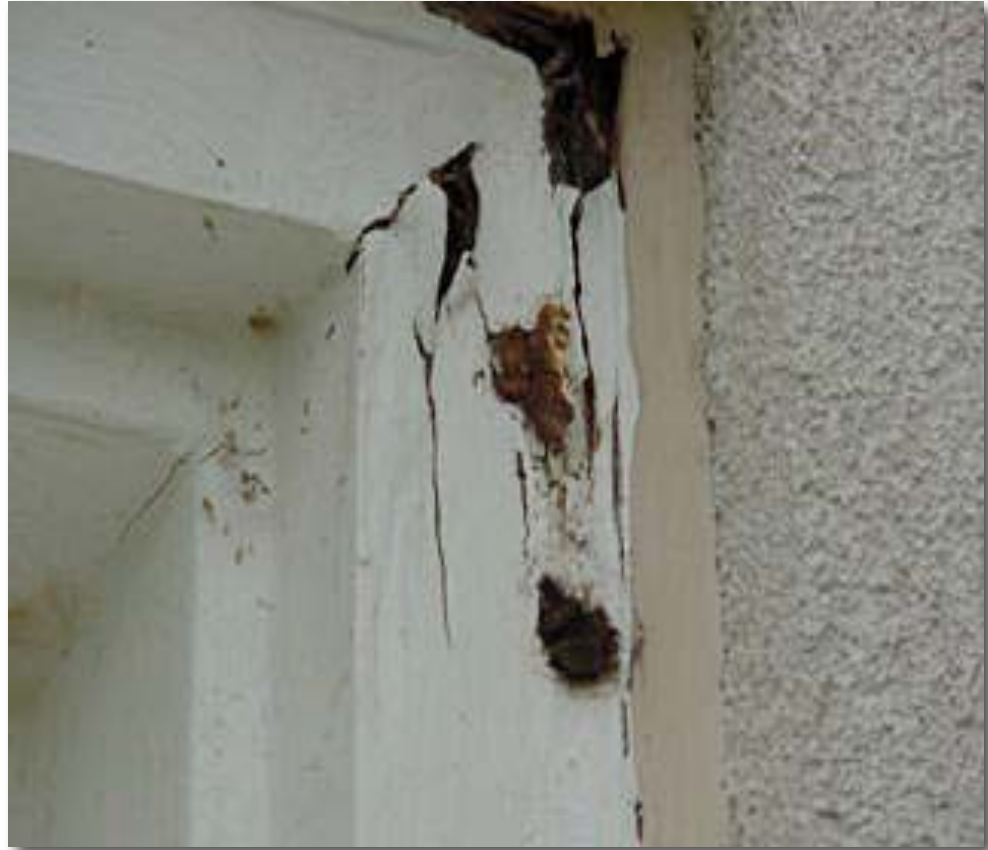
Lack of the proper flashing between the EIFS and surrounding wood trim (windows, doors, wall penetrations) can lead to wicking to the wood.

Flashing must be waterproof to avoid moisture migration.

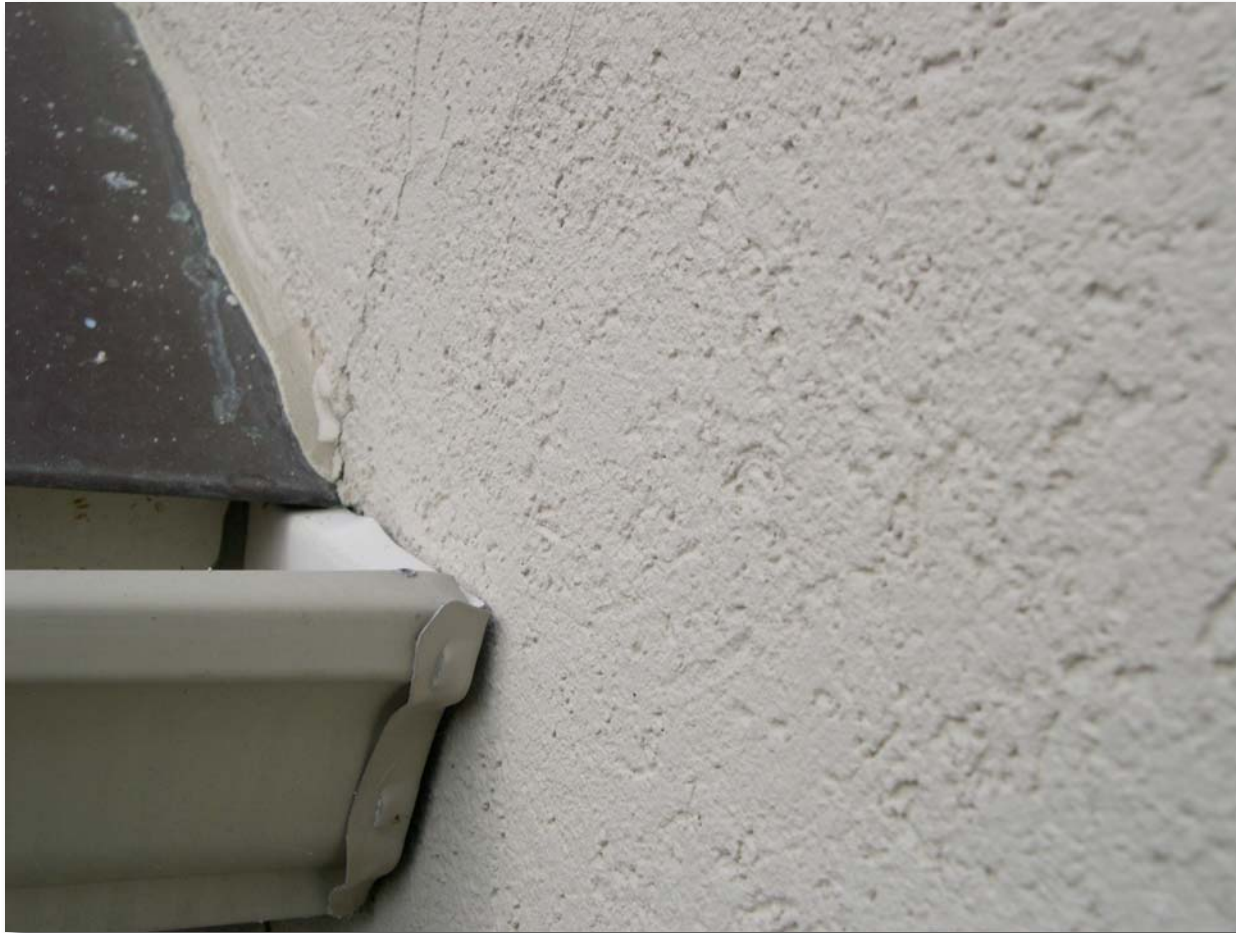
No kick out flashing  
(and note the crack)  
where roof surfaces  
end.

Improper flashing at the  
roof interface with mere  
caulking.

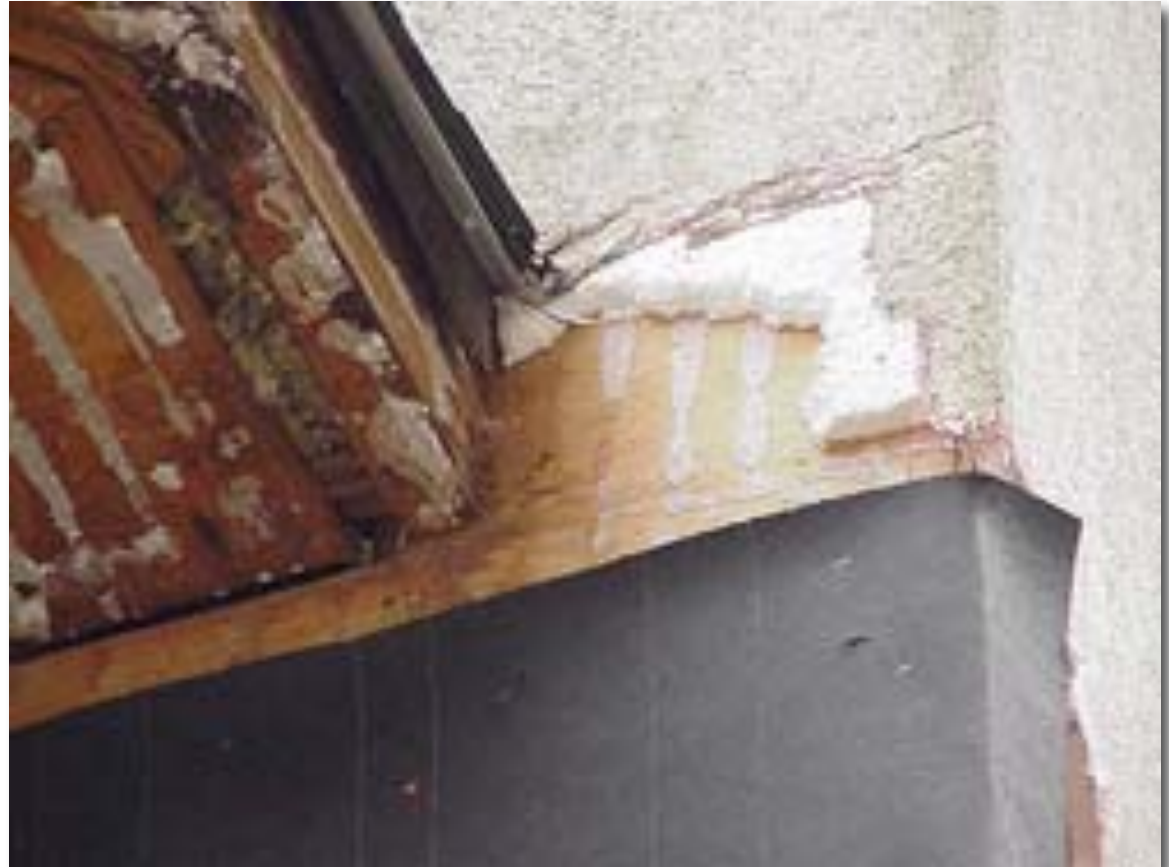
Water leaks with accumulation of water in the Styrofoam, which is held against the underlying sheathing.

Also, note the lack of house wrap under the upper foam.

Improper installation, all around.

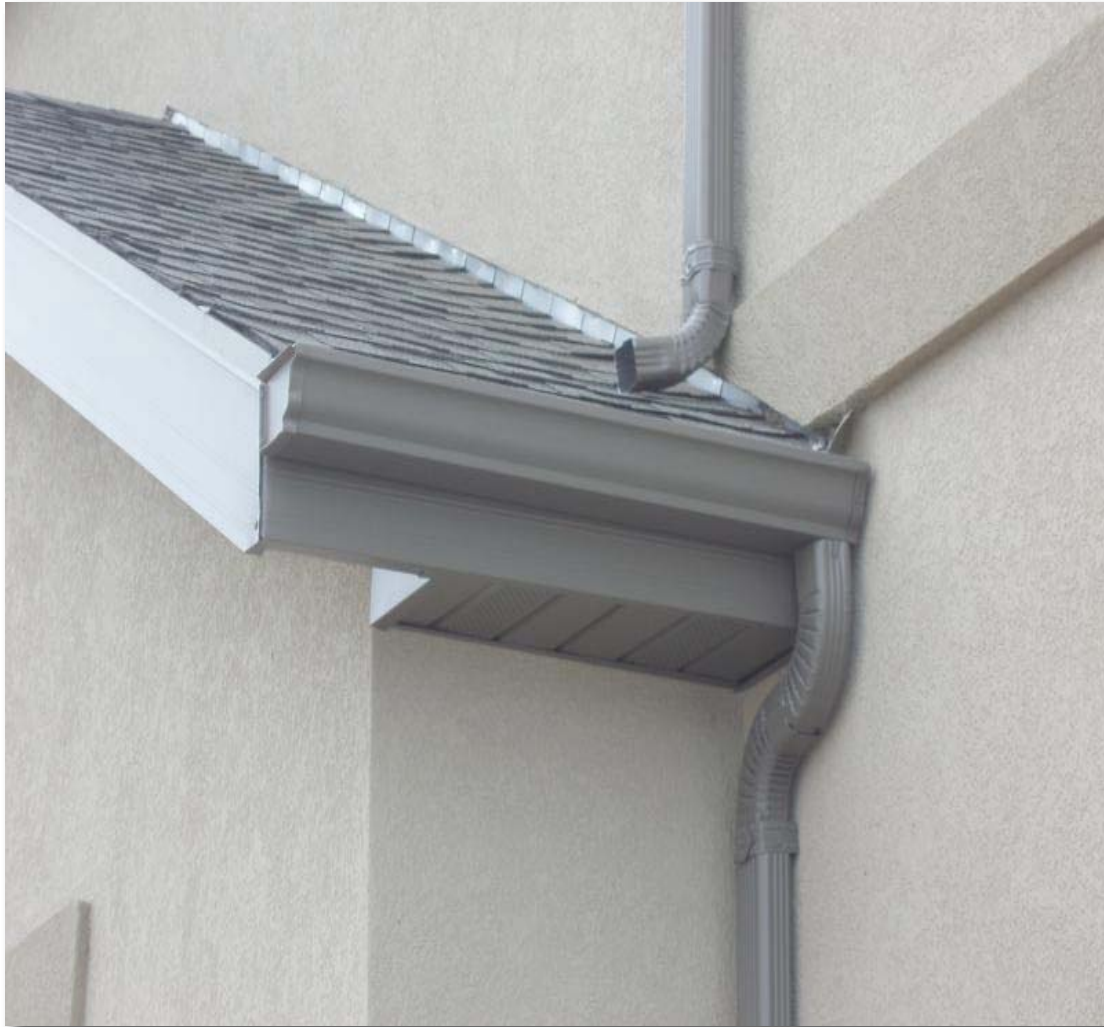
Here we have a properly installed EIFS wall. Rake flashing is good and there is a kick out flashing installed.

No one coordinated with the roofer and the downspout was installed improperly.

Excessive water drained to the lower roof will overcome even a good install.

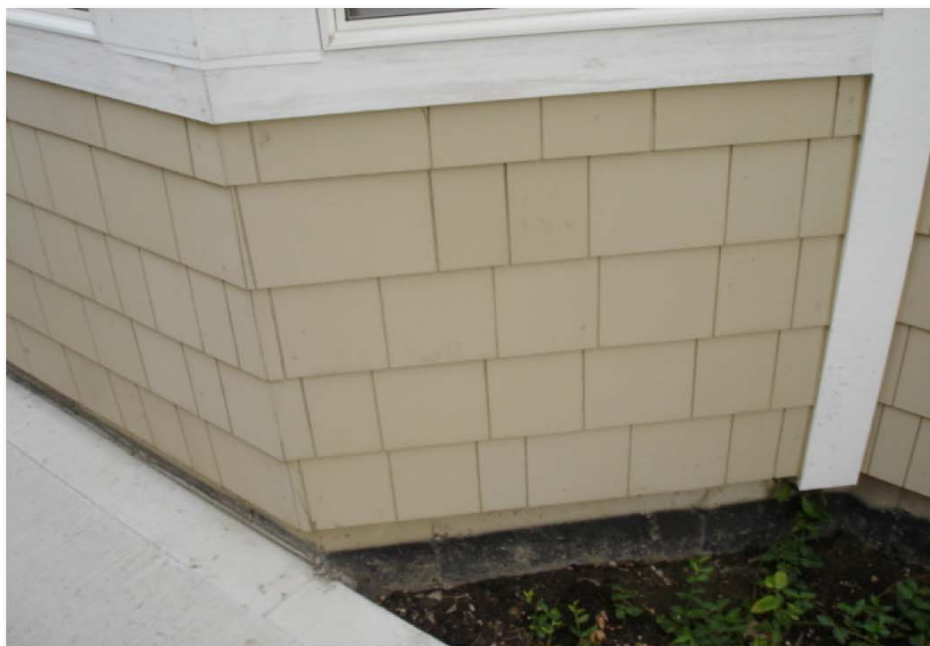
Wooden shingle siding.  
Displays no visible problems.

Thermal imaging reveals moisture buildup. This was verified with moisture meter readings. Thermal imaging can be a great screening tool, but must not be solely relied upon. Always verify with other means!

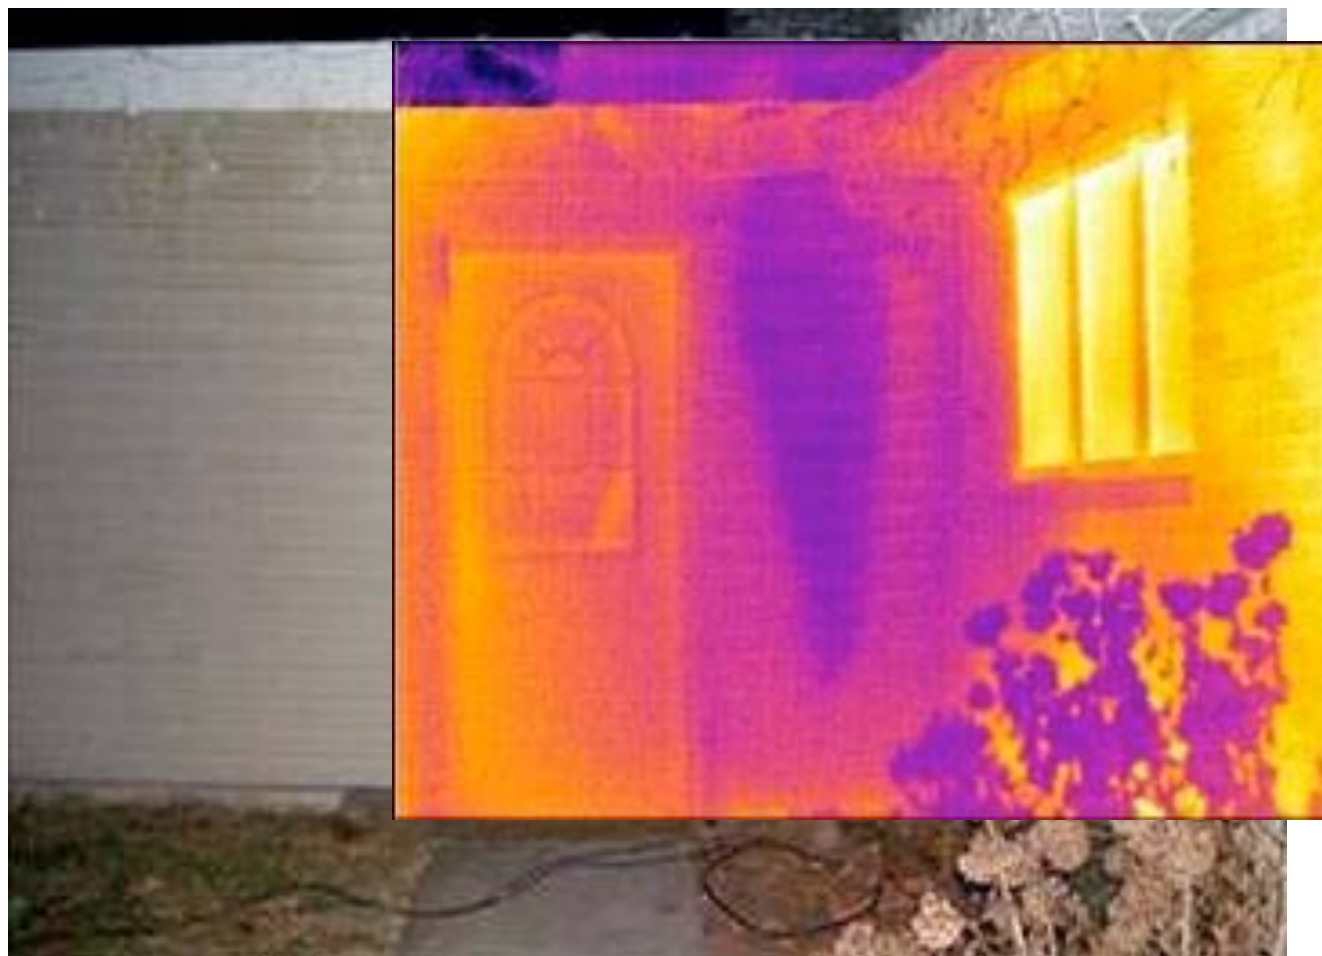
Leakage from downspout and gutter behind wooden siding.

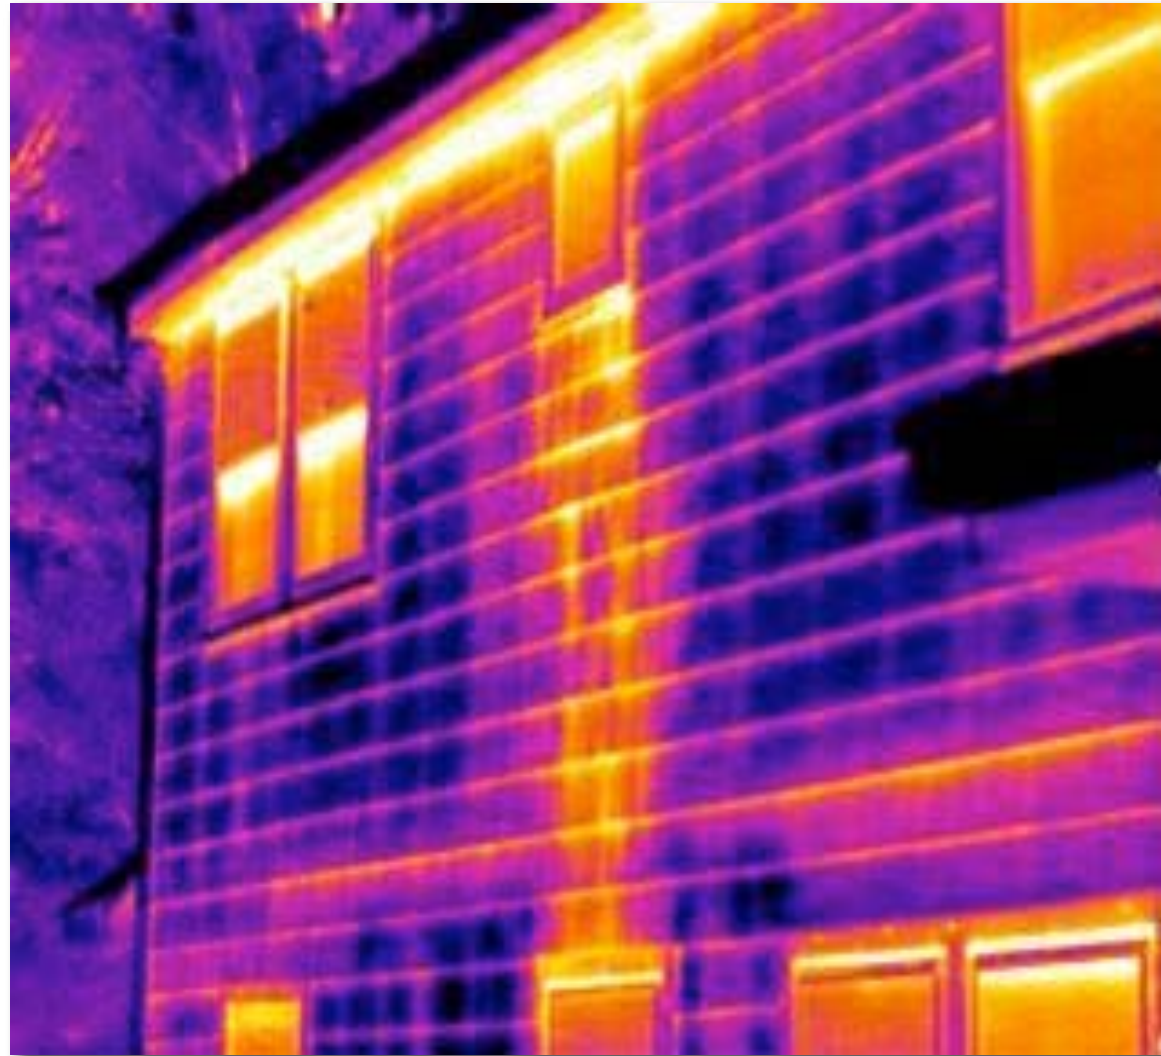
Leakage around window frame because of failed flashing.

With all exterior scanning, remember to avoid direct sunlight reflection or to adjust the reflectivity.

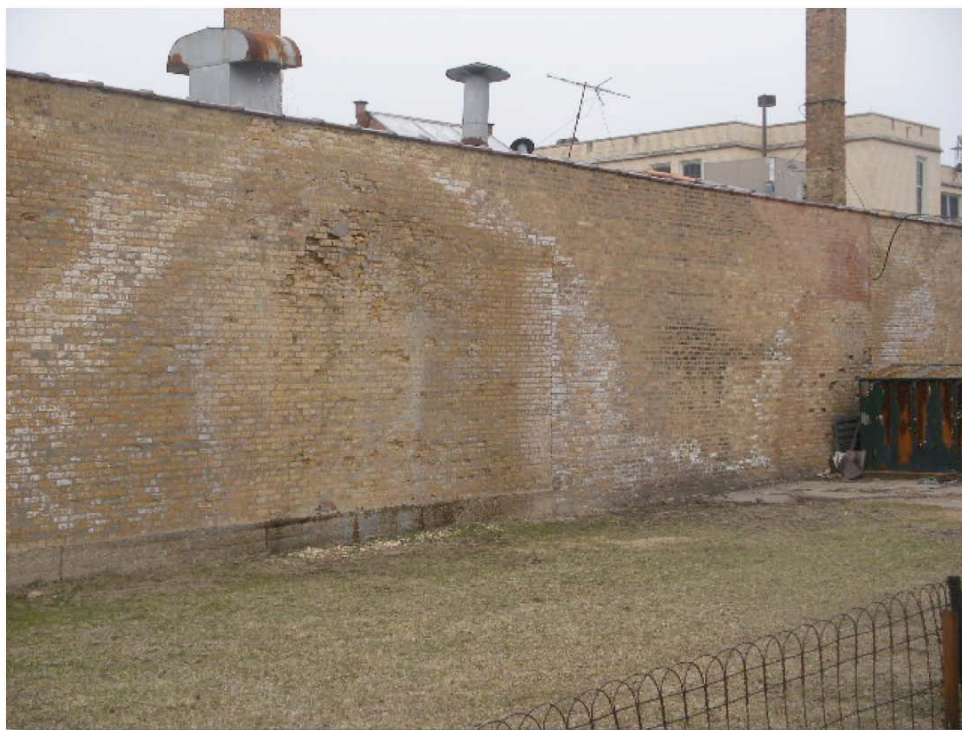
Same building, with marked mortar and brick deterioration seen. Note the efflorescence pattern, which radiates out from the most moist area.

Thermal image of the same area. Note the interior wall interface to the right of the moist area and how it wicks water into it.

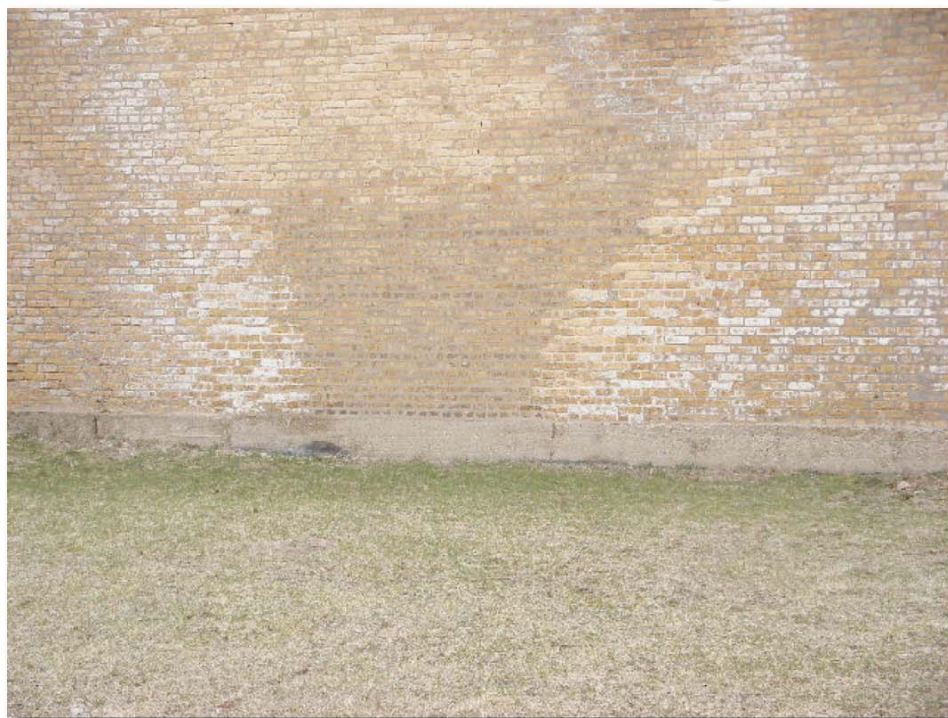
Note how this section of wall, between the two efflorescence fronts, remains warmer and dryer. Efflorescence is often an indication of moisture migration and can show, if traced back, where the original water infiltration began.

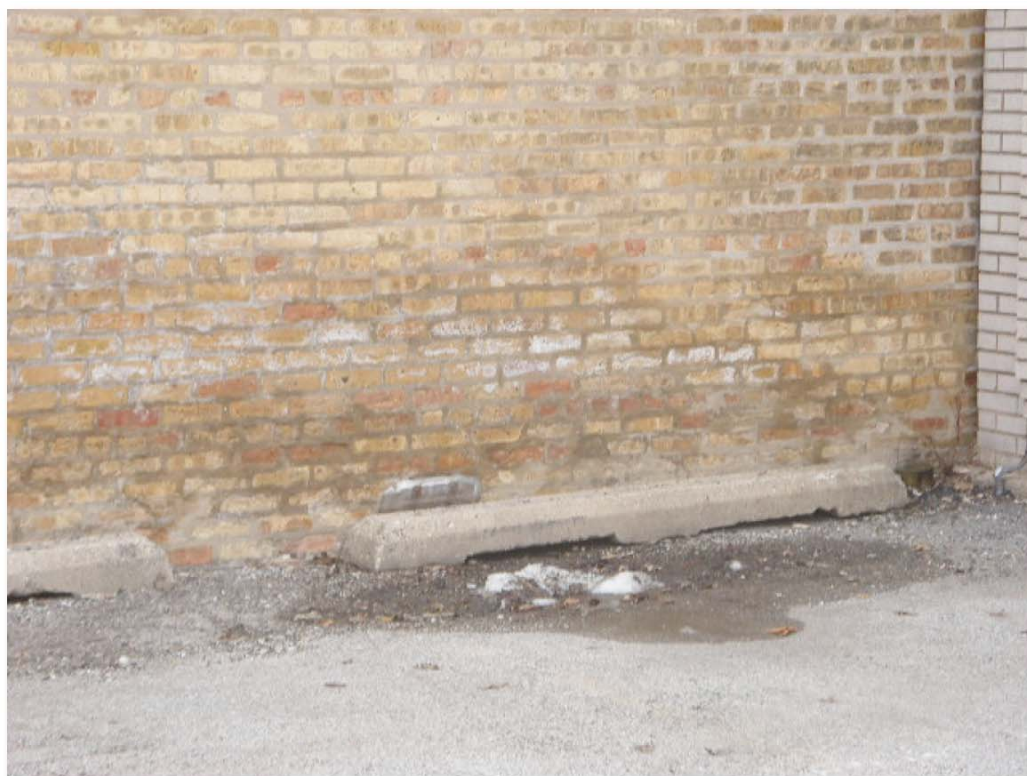
Here we see a common occurrence. The grade around the building is too high and allowing “rising damp” to wick moisture up from the grade.

Note the hotter, vertical anomaly to the on the right? What is it?

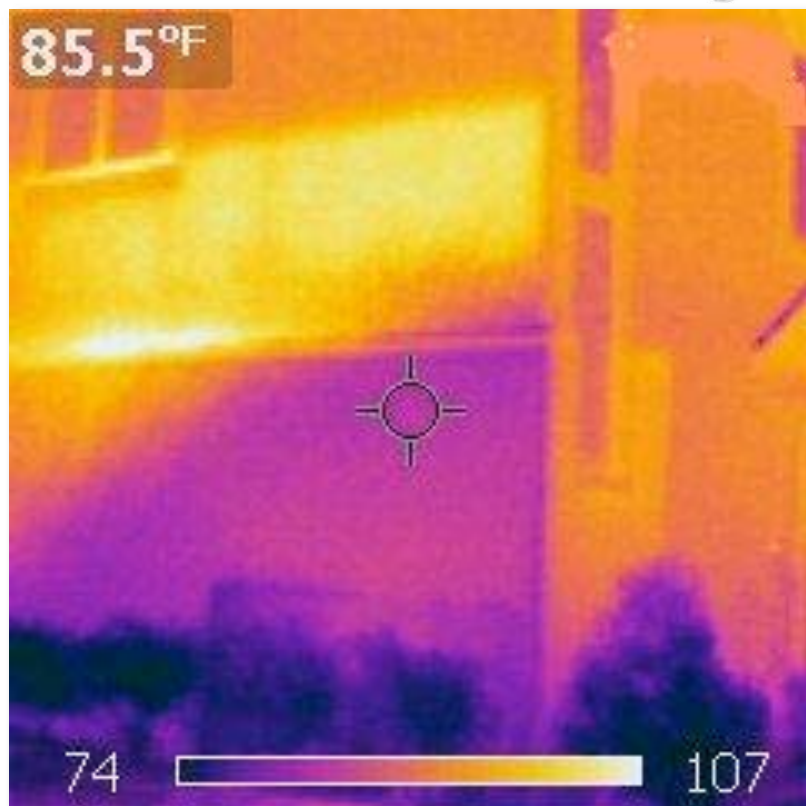
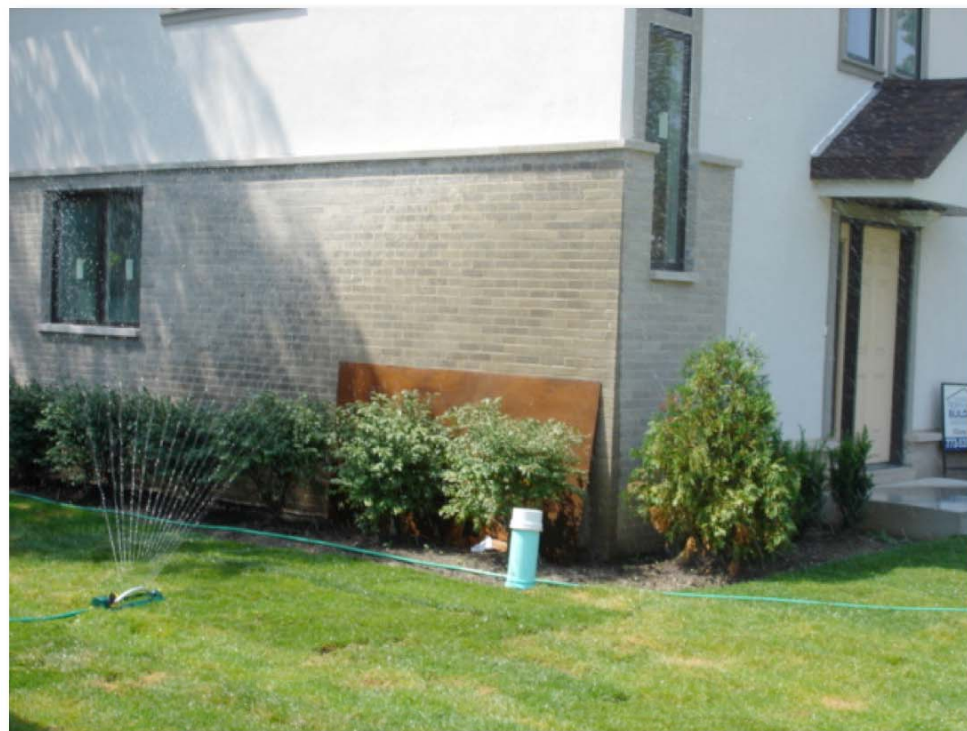
What is the cause of this colder area at the exterior corner of the house?

No. Just watering the lawn. The above picture was taken 3 hours after the watering stopped. Double check everything!

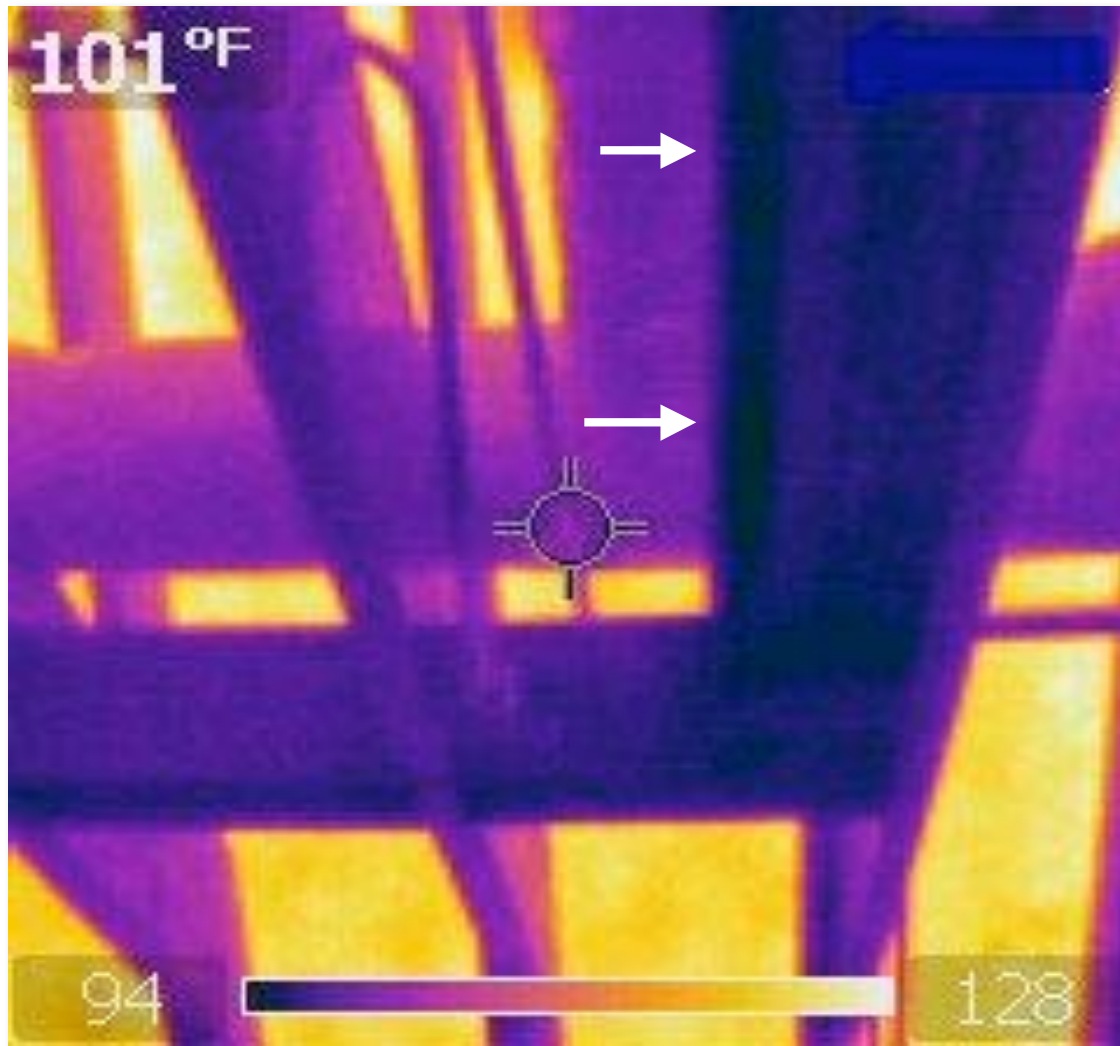
Here we see a ceiling joist structure. Note that the LVL joists on the right are slightly cooler (have slightly greater density and thermal mass) than the dimensional lumber joists on each side.

The denser (and usually stronger) structural members are slower to absorb and radiate heat.

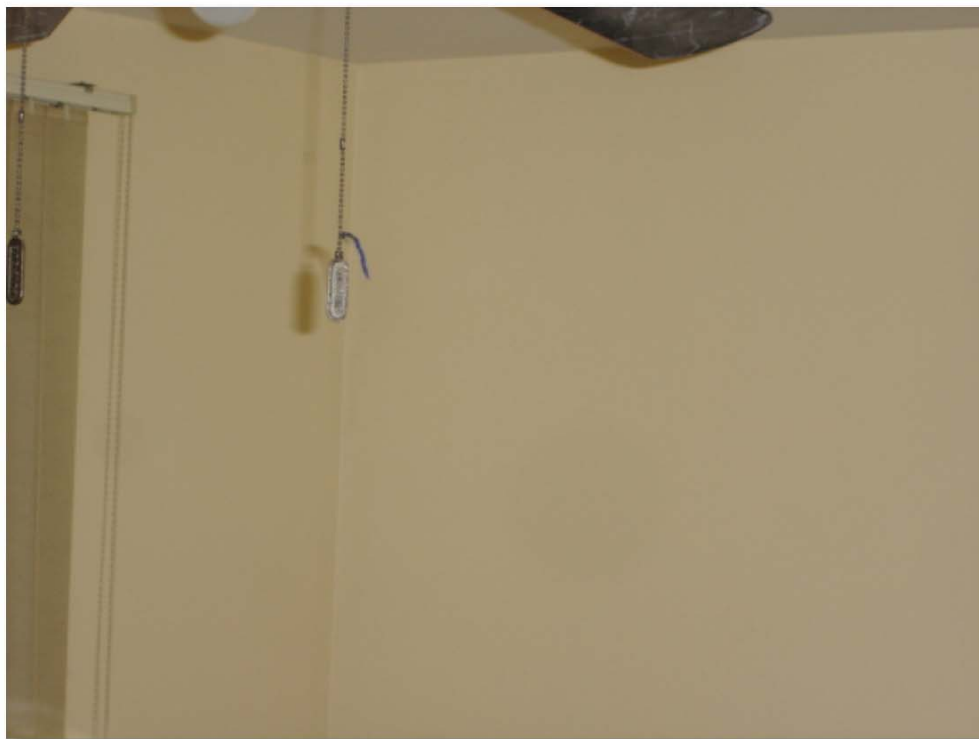
Bedroom wall, seen in visible and infrared light. Note the studs, the insulation gap at the top and the colder readings at the inside corner where the doubles studs are.
