## Study Guide for How to Perform Deck Inspections Course

This course is intended to teach the student how to inspect residential wood decks and balconies. This course does not address the inspection of decks and balconies that are constructed with plastic, composites, or any other material other than solid-sawn lumber.

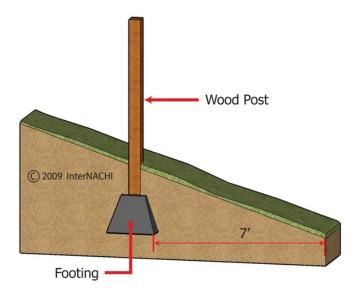
The above left depicts the "7-Foot Rule." On steep properties, the slope of the ground around the footing could affect the footing's stability. The 7-Foot Rule states that there should be a least 7 feet between the bottom of a footing and daylight.

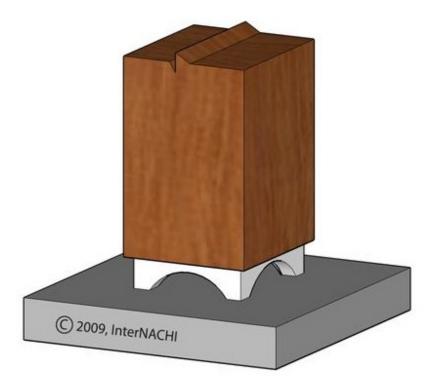
The image above depicts a post base that is not attached to its footing. Posts should be connected to their footings so that the posts don't lift or slip off.

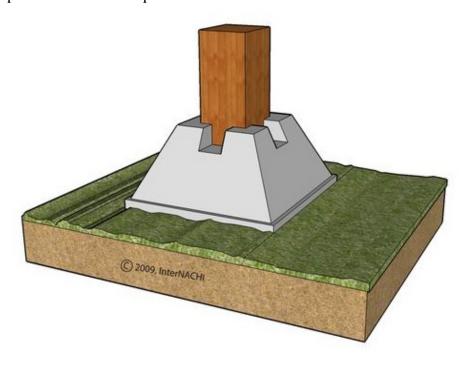
The image below depicts a pre-cast concrete pier. Posts can lift out of pre-cast concrete piers, and piers can slide. Posts should be connected to their footings so that the posts don't lift or slip off.

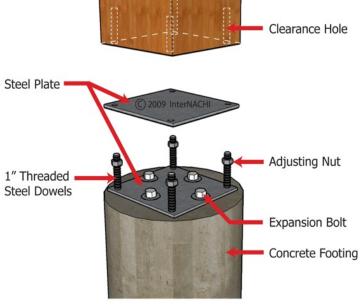
Post

should be at least 6x6, and be no higher than 12 feet; 14 feet is acceptable if cross-bracing is used.

Often, the bottoms of the stringer boards for deck stairs have been found to rest on soil, concrete block or rock, as opposed to resting on posts installed below the frost line. Posts set on soil are subject to rot due to moisture. Posts that are set in unsound footings may cause movement and make the deck above unstable.

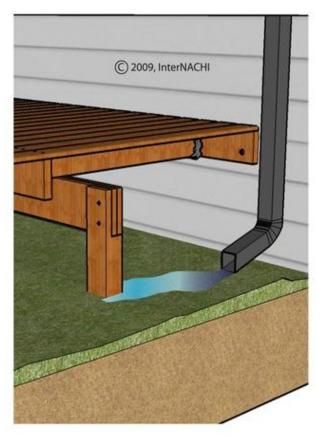
The image right depicts a lawn sprinkler keeping a deck post wet. Lawn sprinkler systems that regularly keep the deck wet contribute to decay.

The image left depicts a downspout contributing to post decay. Downspouts should not discharge near deck posts.

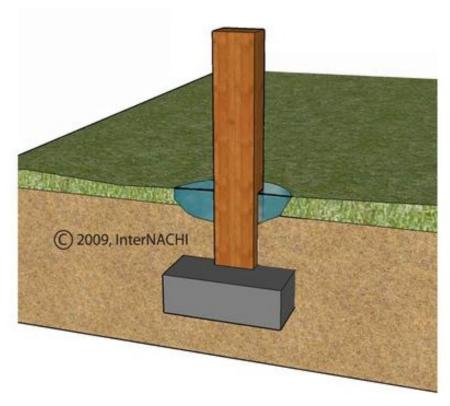
The image below depicts the indentation left over from the footing hole, causing a puddle. Puddles contribute to post decay.

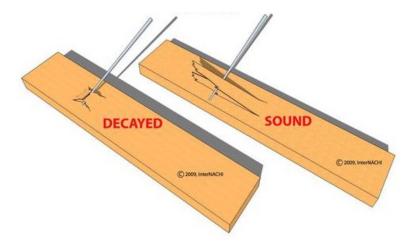
The image below depicts a "pick test." The pick test uses an ice pick, awl or screwdriver to penetrate the wood surface. After penetrating the wood, the tool is leveraged to pry up a splinter, parallel to the grain, away from the surface. The appearance and sound of the action is used to detect decay. The inspector should first try the pick test in an area where the wood is known to be sound to determine a "control" for the rest of the inspection. Decayed wood will break directly over the tool with very few splinters, and less or almost no audible noise compared to sound wood. The pick test cannot detect decay far from the surface of the wood.

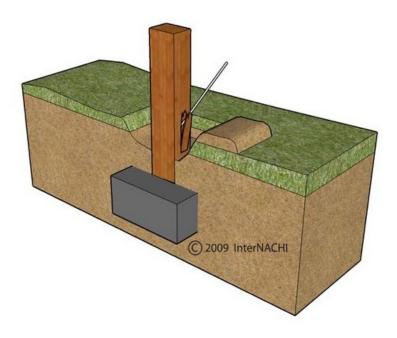
The image below depicts a pick test on a deck post. Although deck inspections are visual-only inspections, inspectors may want to dig down around posts and perform pick tests just below grade level to look for decay.

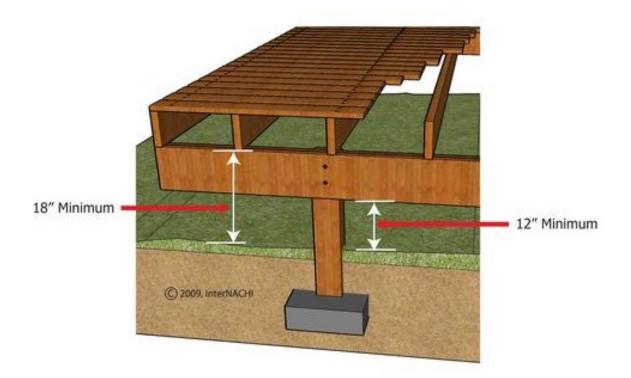
The image above depicts the minimum distance of untreated support members from grade. Untreated joists should be at least 18 inches away from the ground. Girders should be 12 inches away from the ground. However, in many situations, exceptions are made where the elevation of the home does not provide for these minimum distances and the climate is very dry.

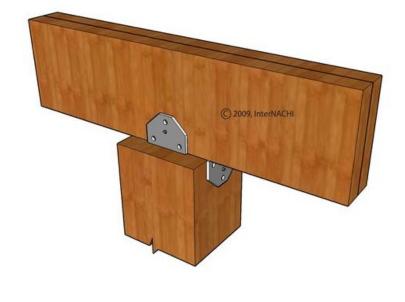
The image right depicts a girder properly resting on a post. Girders should bear directly on posts.

Girders supporting joists should not be supported by deck ledgers or band joists.

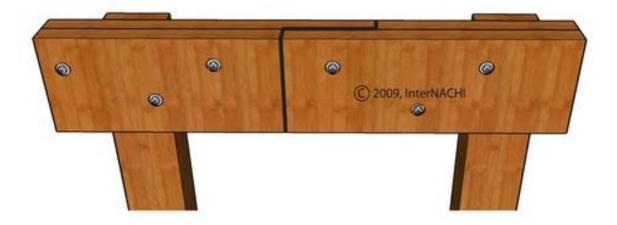
The image above depicts a butt joint improperly located within a girder span. Butt joints in a girder span are generally not permitted unless specially engineered. Butt joints typically must be located above posts.

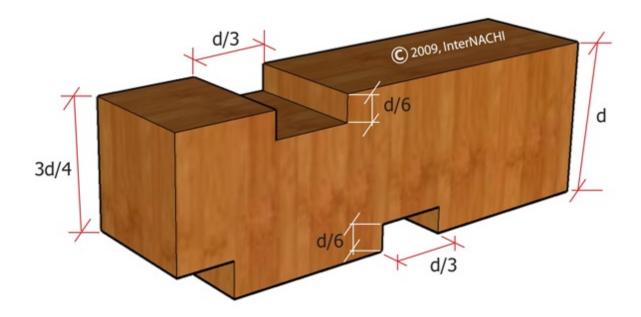
The image above depicts notches in a supporting beam. Notches must be less than one-quarter the depth of the member. On the tension and compression faces, the notch depth must be less than one-sixth of the member's depth, and the notch length must be less than one-third of the member's depth. Notches are not permitted in the middle third of spans, or on the tension face of members that are greater than  $3\ 1/2$  inches thick.

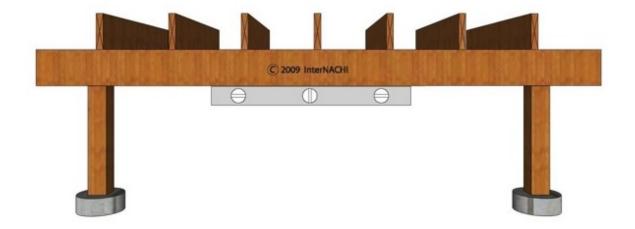
The image above depicts a level being used to check for beam sag. Even with a carpenter's level, it can be difficult to see beam sag from the front.

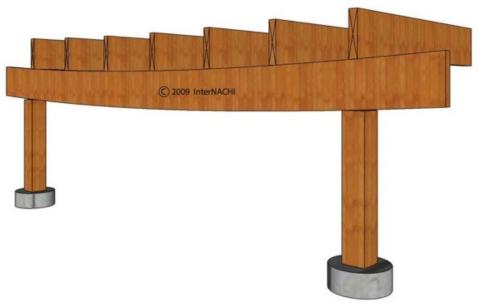
The image above depicts beam sag being eyed-up. Often, it is easier to detect beam sag by eye than with a level by looking along the bottom edge of the beam.

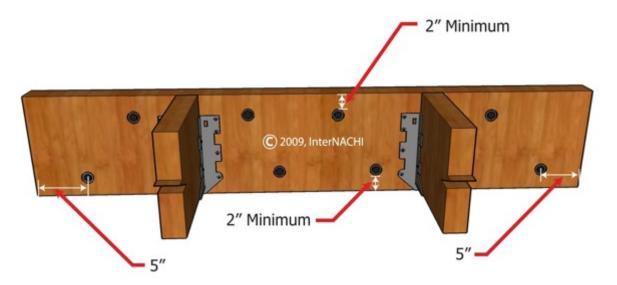
...and so is beyond the scope of a visual inspection. However, the spacing of ledger fasteners required is primarily determined by the length of the joists.

On-center spacing of ledger fasteners in inches = 100 ÷ joist length in feet. A deck with substantially fewer ledger fasteners than that recommended by InterNACHI's formula may be unsafe.

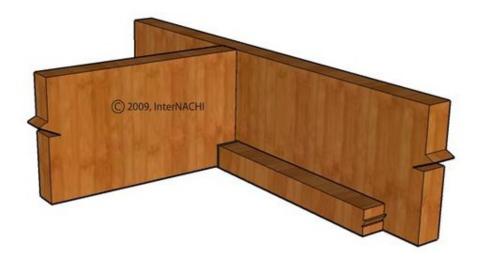
The second is by notching over a ledger strip. The image above depicts a notched joist properly resting a 2x2-inch ledger strip.

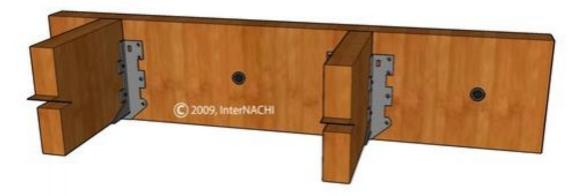
The third is by hanging the joists with joist hangers. The image above depicts joists properly attached to a ledger using metal joist hangers.

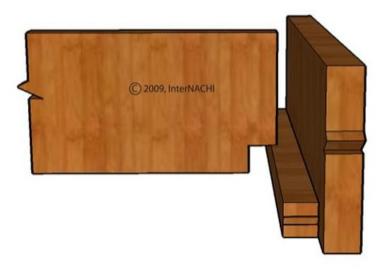
The image left depicts a joist cut too short. Joists may rest on 2x2-inch ledgers like the one above (or in joist hangers), but joists must be cut long enough to reach the ledger or band joist that is supporting them.

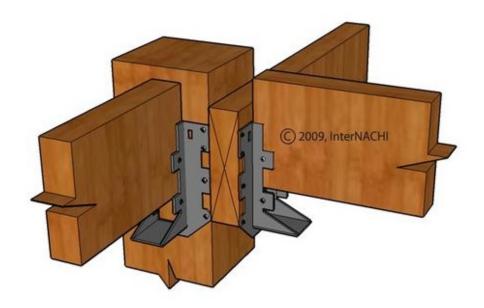
The image left depicts joists that are not fully resting in their joist hangers. Joists should be fully resting in their joist hangers.

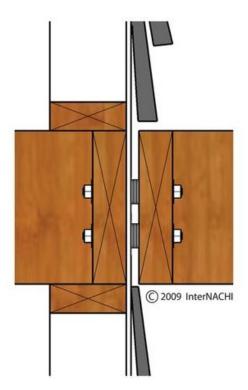
The image left depicts washers being used as spacers between the ledger board and band joist, which is incorrect.

In some cases, the ledger board and band joist are intentionally kept separated by a stack of washers on the lag screw or bolts to allow water to run between the two boards. In other cases, there is insulation between the two boards. Even worse is when the siding or exterior finish system was not removed prior to the installation of the ledger board. Situations like this, where the ledger board and band joist are not in direct contact, significantly reduce the strength of the ledger connection to the structure and are not recommended by InterNACHI, unless the two members are sandwiching structural sheathing.

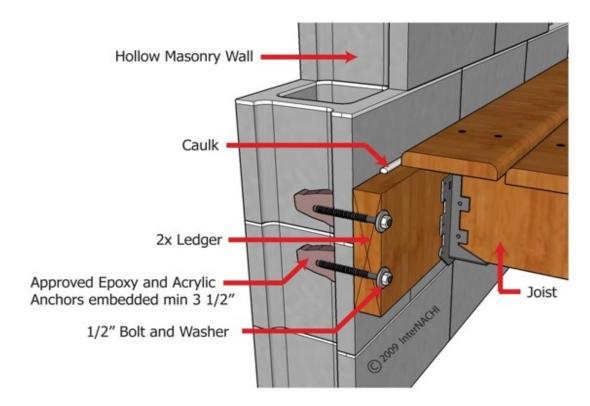
The image above depicts a ledger board attached to hollow masonry. When the ledger is attached to a hollow masonry wall, the cell should be grouted.

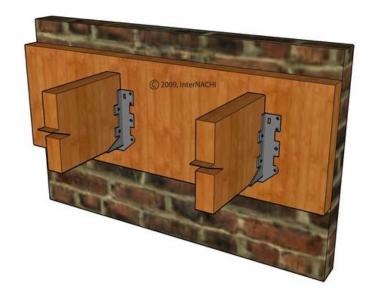
The image left depicts a ledger board improperly supported by brick veneer. Ledger boards should not be supported by stone or brick veneer.

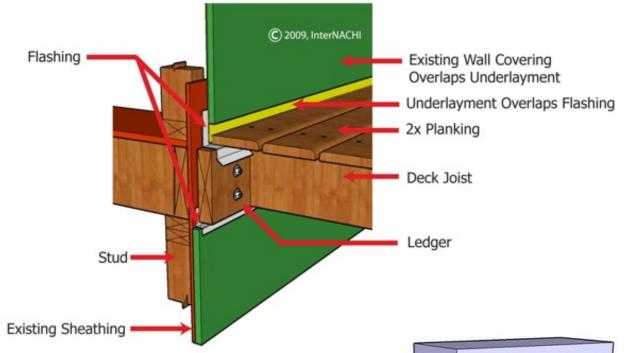
The image above depicts both over and under ledger board flashing. The ledger board should always be flashed even when the home or building has a protective roof overhang.

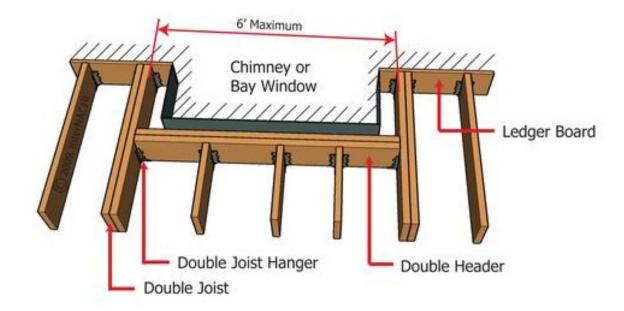
The image above depicts proper framing for around chimneys and bay windows that are up to 6 feet wide. Framing around chimneys and bay windows that are more than 6 feet wide requires additional posts.

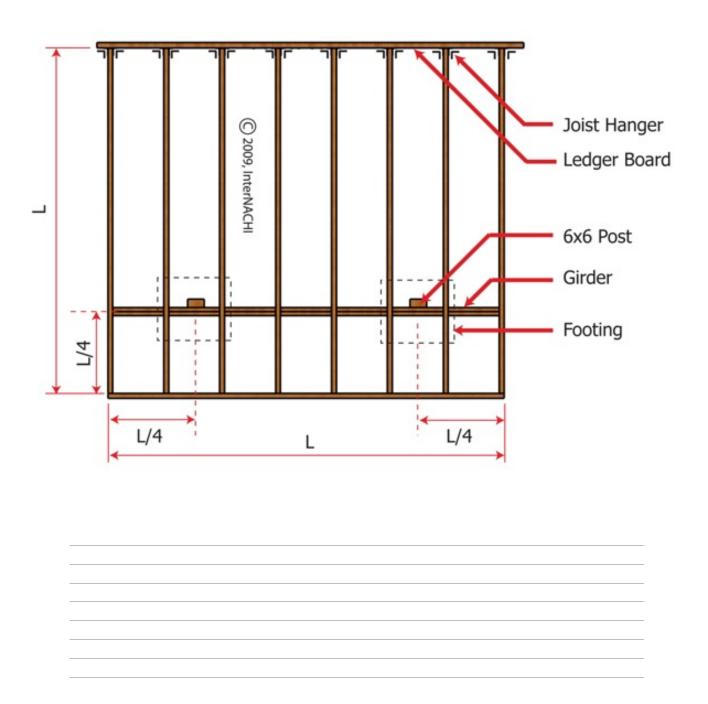
The image below depicts a joist cantilever in the front of the deck and girder cantilevers on both sides of the deck posts. Joists should be cantilevered no more than one-quarter the joist length and three times the joist width (nominal depth). Girders can be cantilevered over their posts no more than one-quarter the girder length.

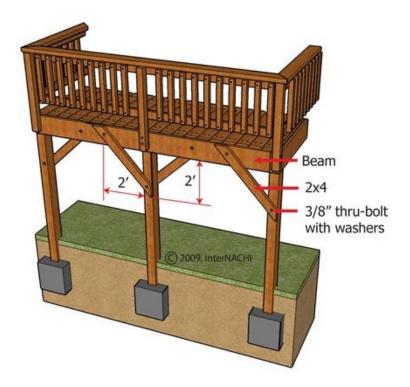
The image left depicts a deck with post-to-joist diagonal bracing. Decks greater than 6 feet above grade should have diagonal bracing from posts to girder, and from posts to joists.

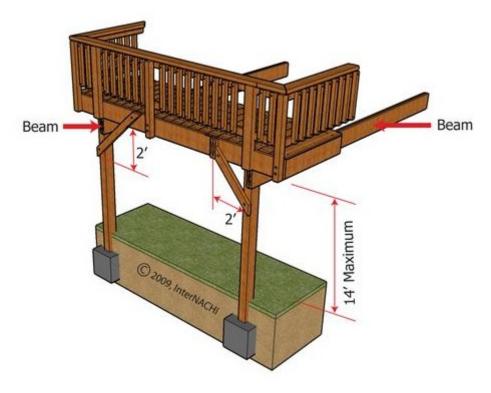
The image below depicts a deck with post-to-girder diagonal bracing. Decks greater than 6 feet above grade should have diagonal bracing from posts to girder, and from posts to joists.

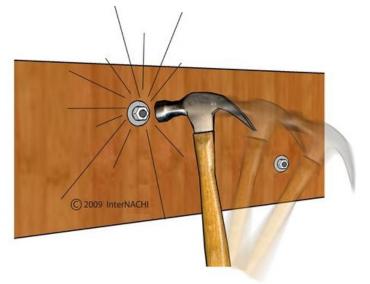
The image above depicts a "hammer test." Depending on how the deck was built, vital connections may have degraded over time due to various factors. Issues such

as wobbly railings, loose stairs, and ledgers that appear to be pulling away from the adjacent structure are all causes for concern. The tightness of fasteners should be checked. If it is not possible to reach both sides of a bolt, it may be struck with a

hammer. The ring will sound hollow with vibration if the fastener is loose. The ring will sound solid if the connection is tight. The hammer test is subjective, so the inspector should hammer-test bolts that can be confirmed as tight or loose, and compare the sounds of the rings to develop a control.

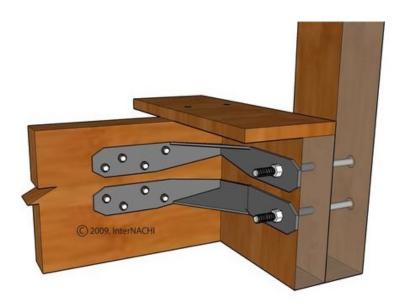
The image above depicts a deck guardrail post properly attached with brackets. Because of leverage, a 200-pound force pushing the deck's guardrail outward causes a 1,700-pound force at the upper bolt attaching the post. It is difficult to attach deck guardrail posts in a manner that is strong enough without using deck guardrail post brackets.

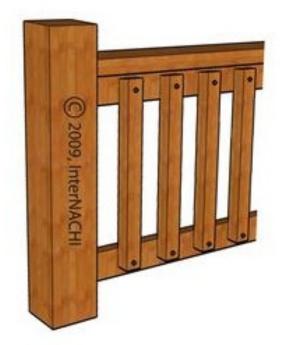
The image above depicts a post and balusters cut level and not shedding water. The end-grain of vertical posts and balusters should not be cut level.

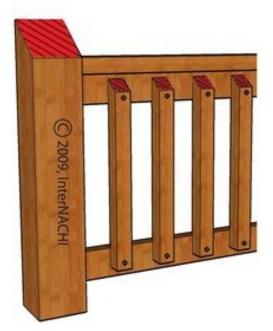
The image left depicts a post and balusters properly cut at angles to shed water. The end-grain of vertical posts and balusters should be cut at an angle.

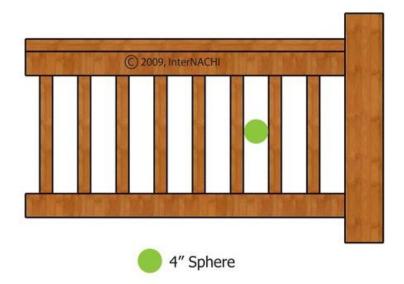
The image right depicts child-unsafe guardrail infill. Infill should not permit a 4-inch sphere to pass through.

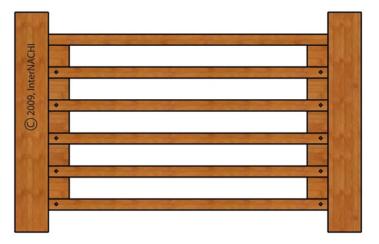
The image left depicts horizontal balustrades. Ladder-type guardrail infill on high decks is prohibited by some local codes because they are easy for children to climb over.

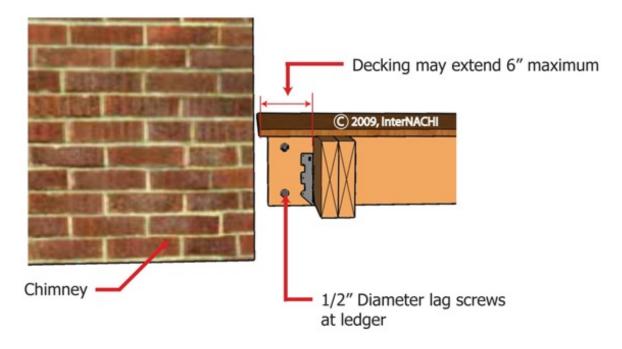
The image above depicts deck framing near a chimney or bay window. The ends of decking boards near the chimney or bay window can extend unsupported up to 6 inches.

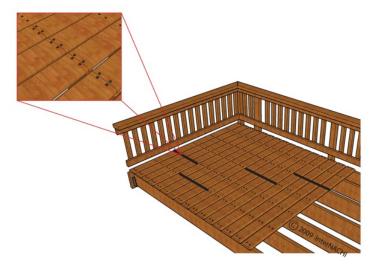
The image left depicts decking lengths. Some are too short. Each segment of decking should bear on a minimum of four joists.

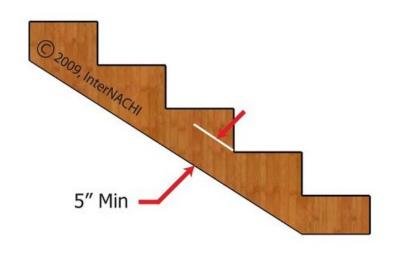
The image right depicts a deck stair stringer. Stair stringers shall be made of minimum 2x12-inch lumber, and no less than 5 inches wide at any point.

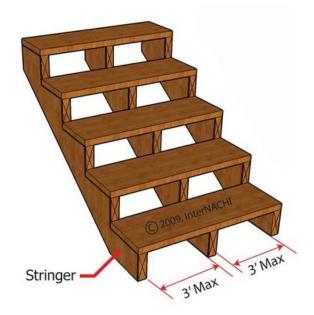
The image left depicts deck stair stringers. Stringers should be no more than 36 inches apart.

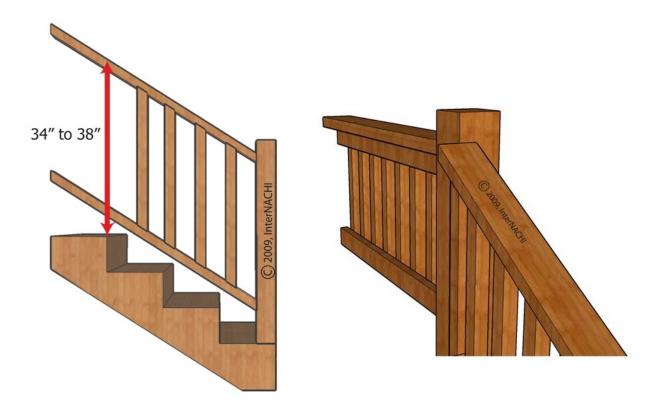
The image above left depicts proper stair handrail height. Handrail height should be between 34 and 38 inches measured vertically from the sloped plane adjoining the tread nosing. The image above right depicts a stair handrail that is not graspable. Many deck handrails improperly consist of 2x6-inch lumber or decking. Handrails should be graspable, continuous, and smooth.

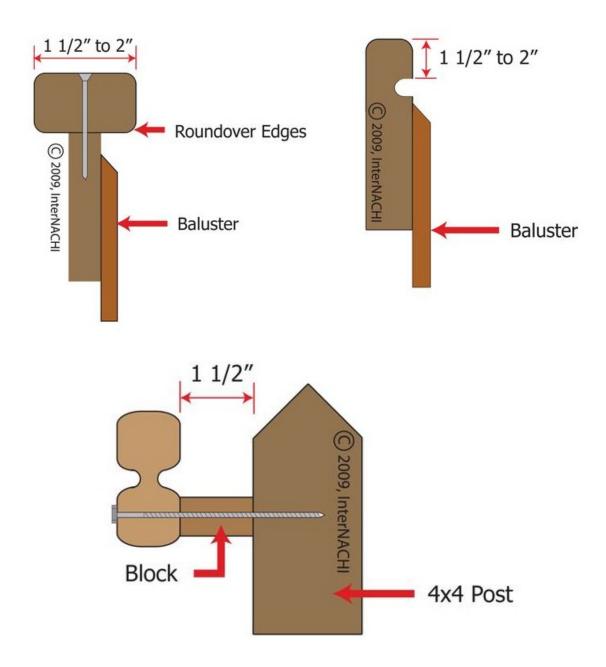
The three images directly above depict graspable handrails. Many deck handrails improperly consist of 2x6-inch lumber or decking. Again, handrails should be graspable, continuous, and smooth.

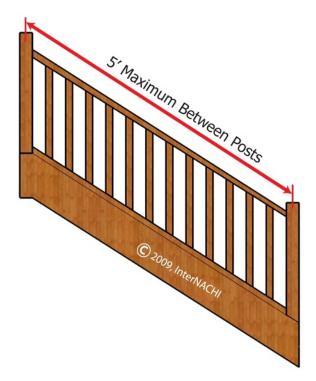
The image left depicts the maximum distance between stair handrail posts. Stair handrails should have posts, at most, every 5 feet.

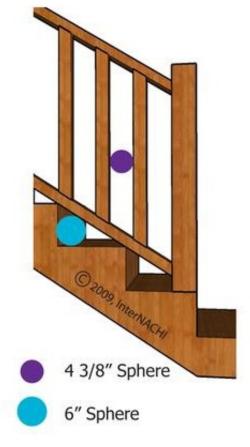
The image below depicts permitted spacing at stairs. Larger spacing presents a child-safety issue.

- Open risers should not allow the passage of a sphere 4 inches in diameter. On stairs with a total rise of 30 inches or less, the size of the open riser is not limited.
- The triangular area formed by a tread, riser and guard should not allow passage of a sphere 6 inches in diameter.
- The opening at guards on the sides of stair treads should not allow the passage of a sphere 4-3/8 inches in diameter.

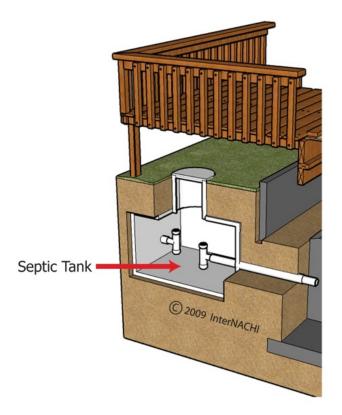
The image left depicts a deck located above a septic tank access. Decks should not be located where they might obstruct septic tank accesses, underground fuel storage tanks, well heads, or buried power lines.

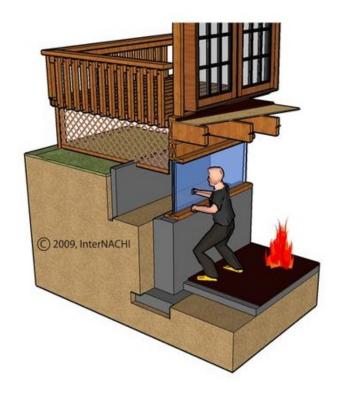
The image right depicts a deck obstructing a basement bedroom's emergency egress window. Egress openings under decks and porches are acceptable, provided the escape path is at least 36 inches in height, and the path of egress is not obstructed by infill or lattice.
